Four Corners Project: FY24 Summary Report

Project Overview

Clarksburg Elementary School Site Visit (Sub-task 3.2)

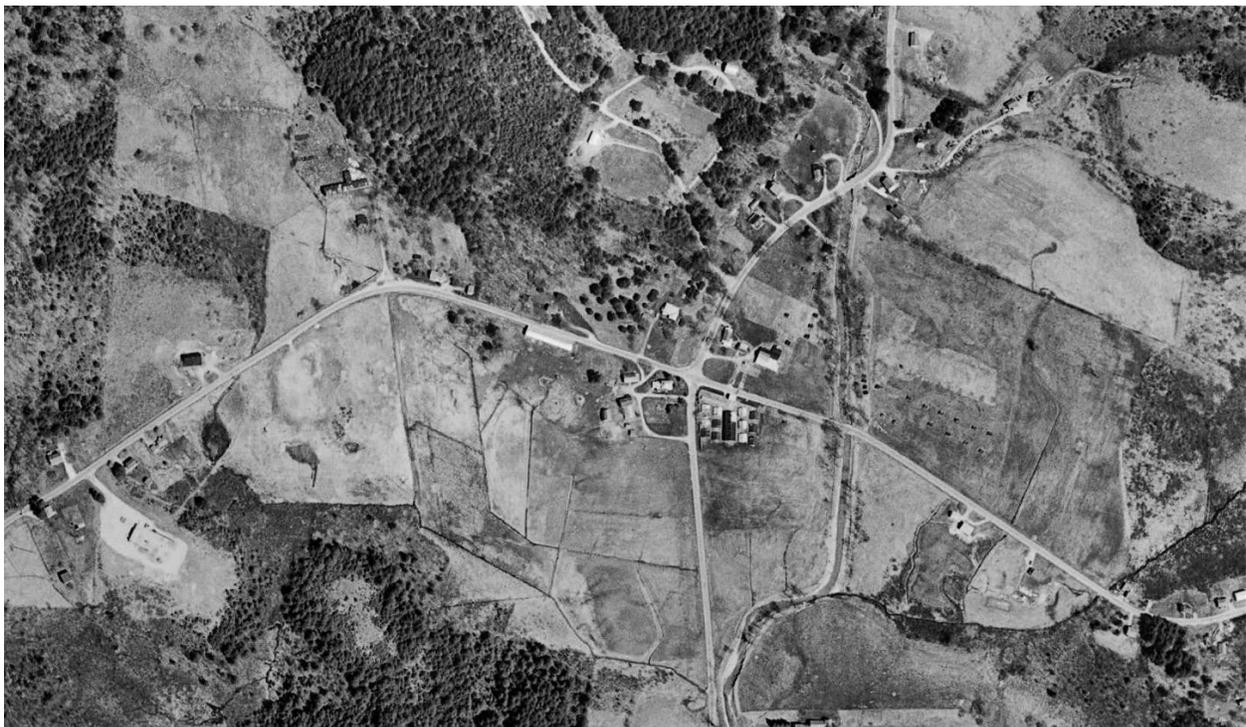
An aerial photo from the 1960s shows the extent of agricultural fields and drainage ditches, and minimal residential development.

Historic aerial photos from the 1940s and 1960 show that the floodplain/wetland complex at that time was primarily farmland, with minimal development in the uplands. Fields were drained by a network of 3,640 linear feet of agricultural ditches. By the 90s, fewer maintained ditches can be seen and today, there are an estimated 1,775 linear feet of ditches under variable maintenance regimes. In the 30+ years since those ditches were retired, wetlands have naturally reestablished, primarily on private property bordering the Town Field and Elementary School. In other areas of the Four Corners, former farmland has been converted to residential development.

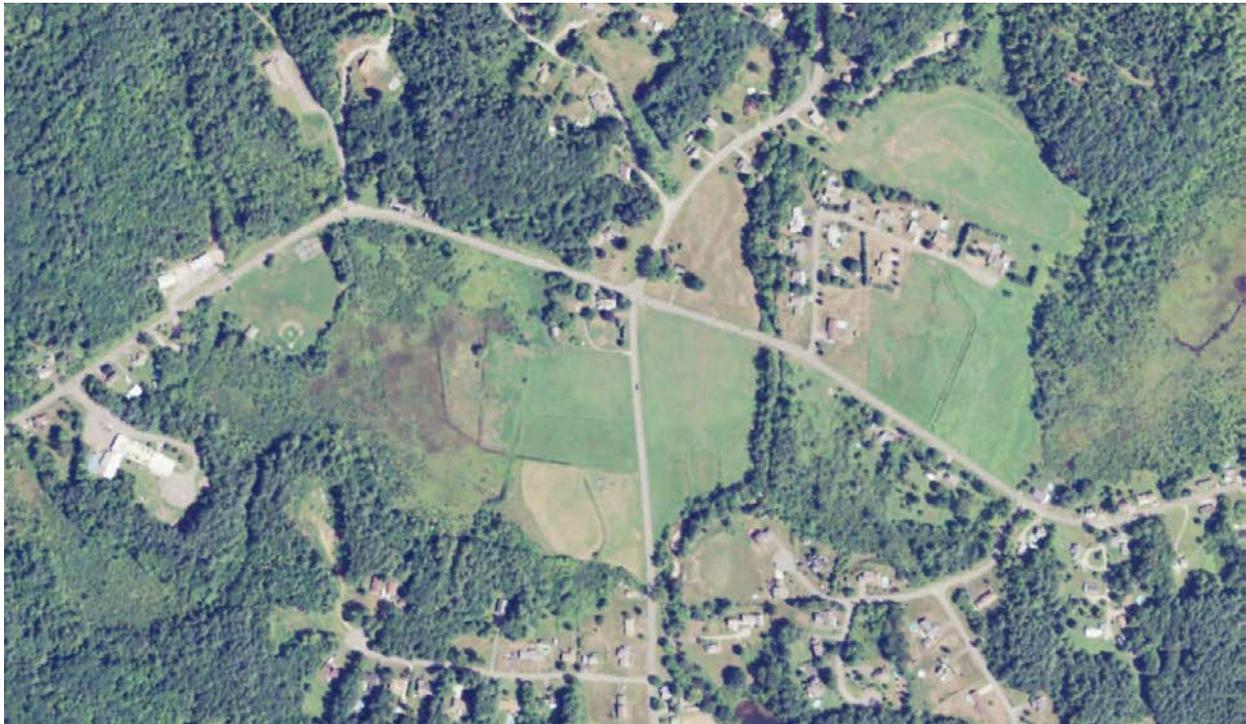
This aerial photo from 2012 shows significant changes in the landscape: some agricultural fields have reforested, some have been converted to residential development, and some are reverting to wetland.

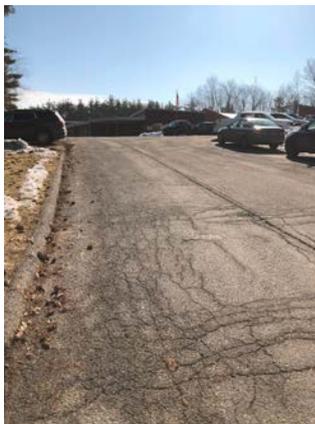
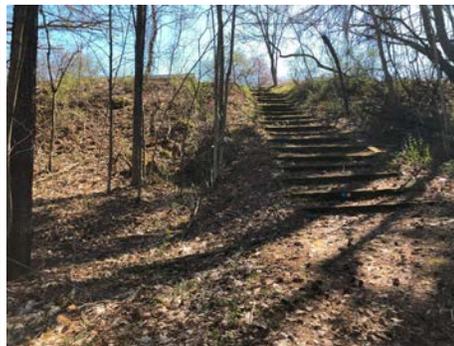
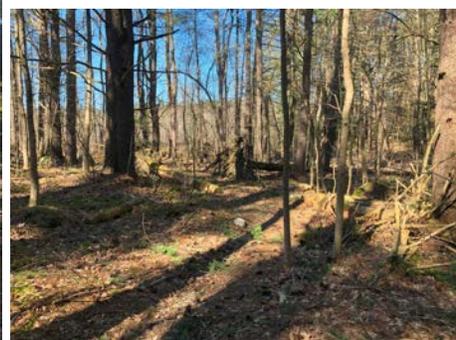
Characteristics/Key Challenges	Preliminary Design Directions/NbS/BMPs
<ul style="list-style-type: none">● Majority impervious cover on excessively drained soils● Driveway grade limits visibility, accessibility, and infiltration of stormwater● Parking layout + lack of sidewalks limits efficient, legible use of the space● Lack of stormwater infrastructure contributes to hillside and trail erosion along the NE slope● Staircase and trail into the wetland complex aren't universally accessible● Some trail portions may conflict with wetland regulations	<ul style="list-style-type: none">● Revise parking lot layout for safer vehicular + pedestrian flow, more efficient use of available parking areas while reducing impervious areas and increased greenspace.● Incorporate permeable hardscape where appropriate● Integrate bioswales and/or rain gardens for stormwater infiltration● Create at least one universally accessible access route into the wetland complex

From L to R: Driveway grade limits visibility, accessibility, and infiltration of stormwater; staircase and trail into the wetland complex aren't universally accessible; some trail portions may conflict with wetland regulations.

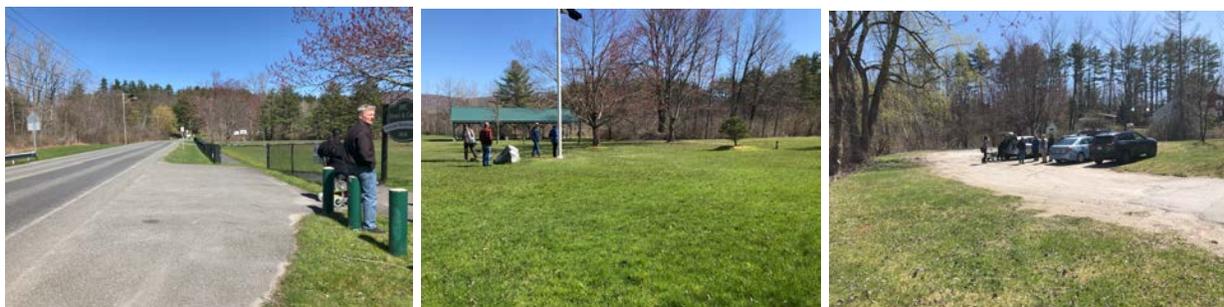
Characteristics/Key Challenges	Preliminary Design Directions/NbS/BMPs
<p>Access + Circulation</p> <ul style="list-style-type: none"> • Single parking lot is poorly defined and underused day-to-day; no adequate parking for big events • Lack of accessible pathways throughout the field and to the pavilion • Emergency route cuts through significant ponding area • No sidewalks or other safe pedestrian access along W Cross Rd • Culverts are undersized <p>Recreation + Gathering</p> <ul style="list-style-type: none"> • Persistent ponding and soil saturation limits the use and enjoyment of the Town Field 	<p>Access + Circulation</p> <ul style="list-style-type: none"> • Revise parking layout to maximize usable space • Upgrade existing pathways + boardwalks for universal access • Integrate parallel parking, pedestrian access, and green stormwater infrastructure along W Cross Road • Enlarge culverts <p>Recreation + Gathering</p> <ul style="list-style-type: none"> • Make grading, soil, and subsurface improvements to the portion of Town Field not identified as wetlands • Manage areas with persistent ponding as restoration and catchment zones • Restore wetlands located around the field pavilion

From L to R: There are no sidewalks along W Cross Road; persistent saturation of Town Field limits use; the Town Field parking lot is poorly defined and has no accessible spots or access.

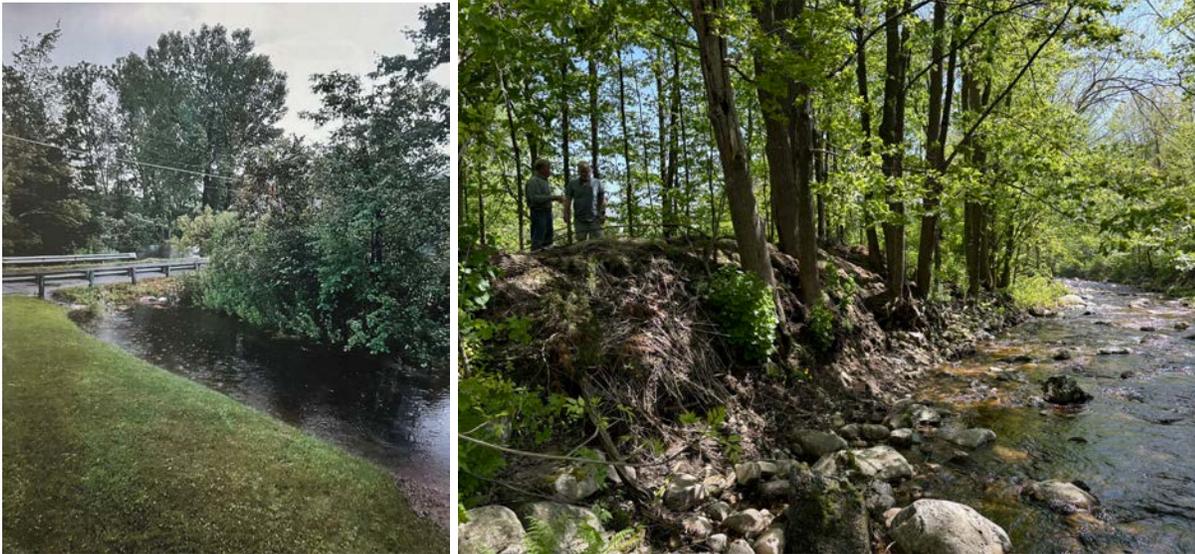
Characteristics/Key Challenges	Preliminary Design Directions/NbS/BMPs
<p>Private Residences</p> <ul style="list-style-type: none"> ● Extensive and frequent flooding reported and observed at four residences ● Chance of flood stranding is high for Lescarbeau and Maynard properties <p>Road + Flood Infrastructure</p> <ul style="list-style-type: none"> ● Culverts are undersized, damaged, or sedimented ● Sediment and stormwater flows reported from Lincoln Drive ● Large berm on Hudson Brook provides flood protection to Stoneybrook Dr homes ● Backflow preventer observed on culvert draining the Wilson Property to Hudson Brook ● Middle Road reported as main emergency route <p>Fields + Farm Ditches</p> <ul style="list-style-type: none"> ● Haying is the predominant use ● Two landowners are actively maintaining ditches ● Historic changes ca. 1990 by town on Harvey property reported to have changed flood dynamics at confluence of Tamarac + Hudson Brook 	<p>Private Residences</p> <ul style="list-style-type: none"> ● Conduct detailed HEC-RAS study of Hudson + Tamarac Brook ● Investigate stream reconfiguration ● Create evacuation notification system for anticipated flood events ● Explore options for structure elevation and transfer of HVAC systems to attic ● Public buy-outs for frequently flooded properties as last resort <p>Road + Flood Infrastructure</p> <ul style="list-style-type: none"> ● Replace or repair culverts on Tamarac Brook and from Pierce farm ditch at Cross Road ● Ensure emergency management plan is in place to maintain Middle Road in all situations ● Assess purpose and impact of backflow preventer. Remove to allow flood diversion if feasible. <p>Fields + Farm Ditches</p> <ul style="list-style-type: none"> ● Assist farmers in filing all necessary paperwork to allow for ongoing ditch maintenance ● Evaluate restoration opportunities for abandoned ditches ● Explore possibilities for pond creation and public access on unmanaged areas

From L to R: The Tamarac Brook culvert at Cross Road appears to be impeding flow following 2" rainstorm (Lescarbeau). A berm along Hudson Brook provides some flood protection, but would be difficult to build in today's regulatory environment. .

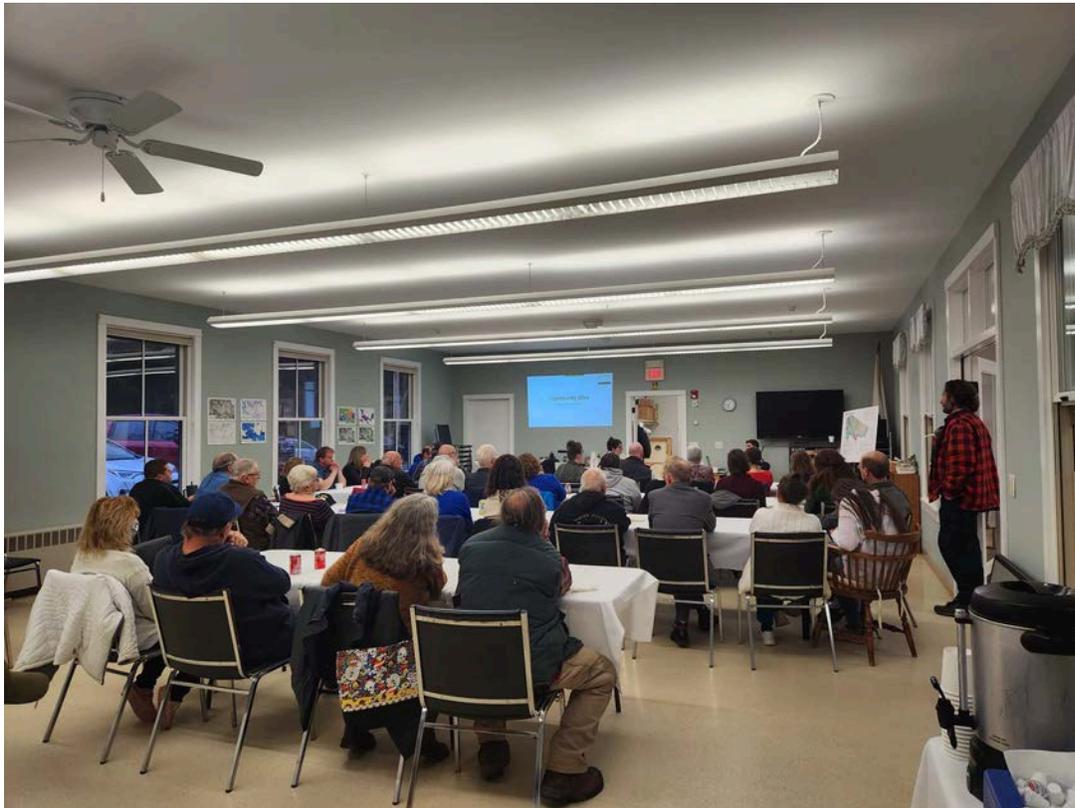
Design Workshop #1 was a presentation-style workshop that reviewed the broad ecological and hydrological patterns that contribute to stormwater and flooding challenges in the Four Corners.

- Review of the inherent and dynamic influences that contribute to and exacerbate problematic stormwater and flooding issues
- Review of specific challenges and preliminary design directions at each of the Town Sites
- Overview of design and management precedents such as:
 - Flood friendly culverts
 - Retentions/detention ponds
 - Green infrastructure
 - Adaption of flood prone sports fields

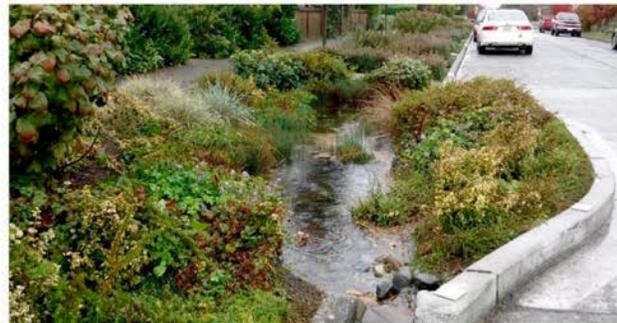
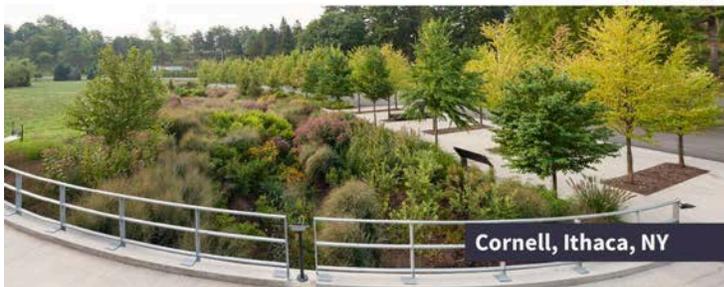
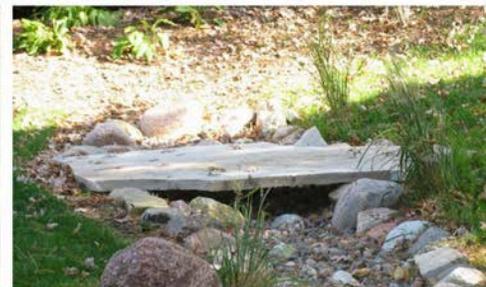
Uplands + Built Environment Precedents: Bioswales, Rain Gardens, Dry Creeks

- Increased infiltration of run-off
- Reduced sediments, turbidity, + pollutant loads = improved water quality
- Educational opportunities
- Increased biodiversity + habitat

Design Workshop #1 gave an overview of several BMPs that were relevant to the Four Corners project.

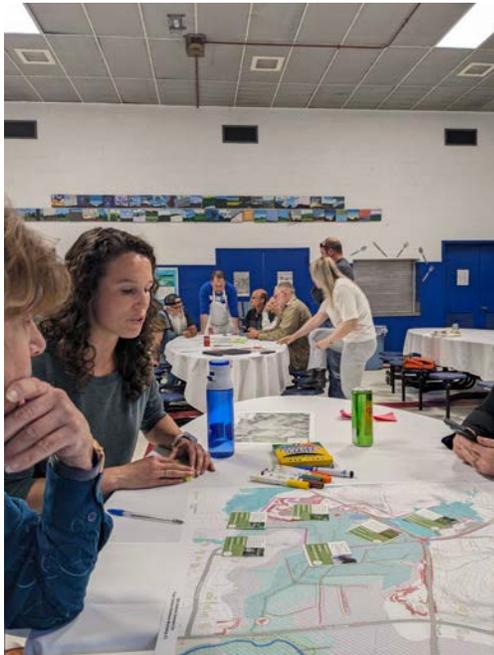
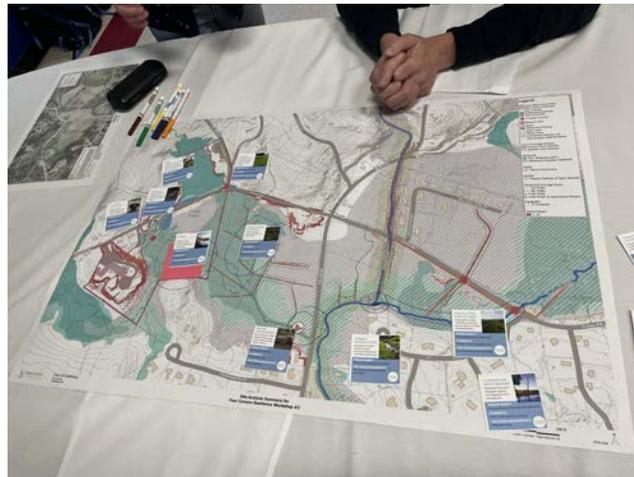
Design Workshop #2 focused on prioritizing and siting interventions for each of the project's goal categories.
